Illinois Commerce Commission  
Assessment of AmerenCIPS'  
2001 Reliability Report and  
Reliability Performance for  
Calendar Year 2001

Pursuant to 83 Ill. Adm. Code 411.140

October 2002

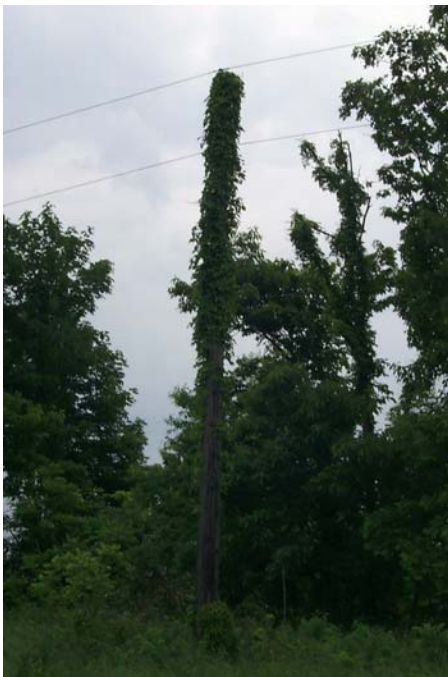
This 12kV rural circuit supplies mostly agricultural and residential customers near the communities of Annapolis, York, West York, Hutsonville, and West Union. X86-543 was a worst performing circuit in 2001 due to SAIFI, and has had a relatively high SAIFI for the last three years. Of the roughly fifty outages in 2001, eleven were due to trees, ten to weather, ten to animals, eight to overhead equipment problems, and five are categorized as unknown. AmerenCIPS conducted its own inspection of this circuit, resulting in several reconstruction jobs. Tree trimming was completed in March 2002. Staff's inspection confirmed that thorough tree trimming had recently been completed throughout the circuit. Staff informed AmerenCIPS of its discovery of a broken pole, near York, and AmerenCIPS was responsive in correcting this potentially hazardous condition. Overall, the facilities appeared to be in good shape, with relatively few issues noted by Staff. Items noted were: several locations where vines grew to the primary conductors (Photo 1), shell-rotted poles, a few poles with split tops or split cross-arms, and a transformer that had apparently had its mounting brackets bent (Photo 2). This is a very lengthy circuit, and Staff believes AmerenCIPS has done a good job with it, though it may also wish to review tap line fusing.

**Photo 1: Vines Growing to Primary Level of Pole (Circuit X86-543)**

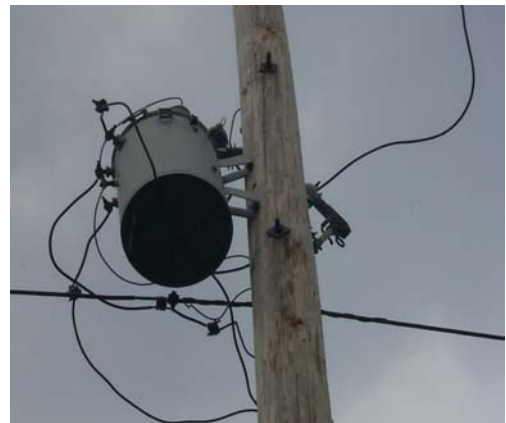
**Photo 2: Bent Mounting Brackets on Pole-mounted Transformer (X86-543)**

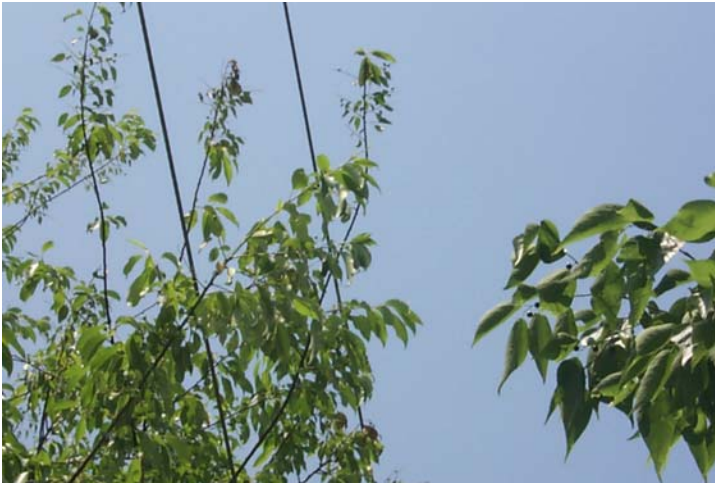
This 12kV circuit, a 2001 worst performing circuit due to SAIFI, supplies mainly residential, commercial, and agricultural customers in and around the communities of Paris and Vermillion. Of the thirty-nine outages on this circuit in 2001, nine were overhead equipment related, eight due to weather, six due to trees, five due to animals, and four were due to unknown causes. Tree trimming for this circuit was last completed in 2000. AmerenCIPS states most tree-related outages were due to a problem area near a golf course where trees were difficult to trim due to access, however, Staff discovered trees contacting the lines throughout the circuit (Photos 3 & 4). Staff believes AmerenCIPS should schedule tree trimming on this circuit again soon. Other than having a multitude of tree contacts, the circuit appeared to be well maintained. Staff noted one pole that exhibited woodpecker damage. Staff's recommendations for this circuit, in addition to trimming the trees again, is to be proactive with the installation of animal guards in specific areas where squirrel populations are high.

**Photo 3: New Growth Contacting Primary in Paris (Y51-506)**

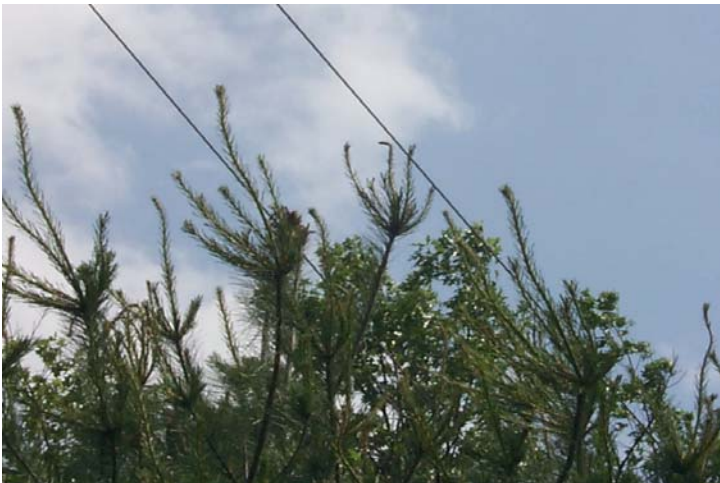
**Photo 4: Conifer into Primary in Paris (Y51-506)**

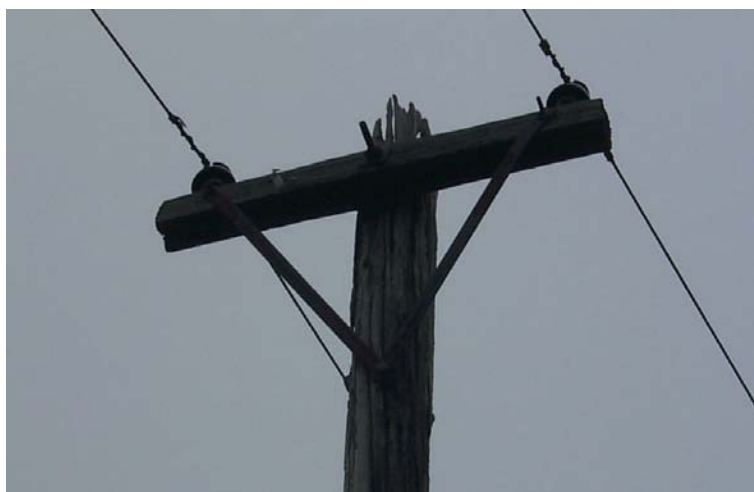
This 12kV circuit, a 2001 worst performing circuit due to SAIFI, supplies mainly agricultural and residential customers in and around the community of Forrest. Of the twenty-two outages on this circuit in 2001, nine were weather-related, four due to animals, three due to overhead equipment problems, and three were due to unknown causes. Tree trimming was last completed in the first quarter of 2002. Staff noted only one location where a tree was growing close to the primary. Staff encourages AmerenCIPS to follow-through on its plans to evaluate the need for additional tap line fuses. Staff's main concern for customers supplied by this circuit relate to the apparent age of the facilities, with visibly deteriorated poles throughout the circuit (Photo 5). Staff also noted a mid-span broken primary strand on a rural tap line, which could also be attributed to the age of the wire. Two pole replacement projects were completed in 2000, and Staff believes AmerenCIPS should consider additional projects.

**Photo 5: Shell-rot Pole with Splitting Cross Arm (X72-535)**

AmerenCIPS should consider accelerating its pole inspection/replacement project in specific areas in order to address the many poles, some supporting main-feeders, which are severely shell-rotted. Its new specific project to install tap-line fusing should help isolate interruptions caused by failing equipment, but Staff is concerned by the deteriorated condition of poles observed during its circuit inspections, especially on circuits V58-507, near Roseville, and X72-535, near Forrest.

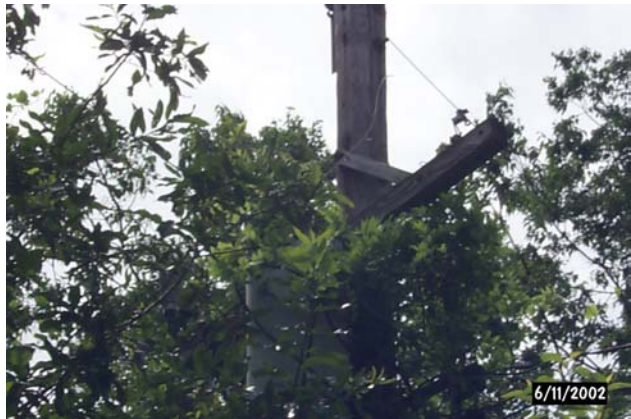
This 12kV circuit, was not a worst performing circuit in 2001, but was inspected by Staff due to its relatively high SAIFI during both 2001 and 2000 (SAIFI=2.7 in 2000). S86-582 supplies residential and commercial customers in and around the community of Murphysboro. Of the forty-one outages in 2001, twelve were weather-related, seven due to trees, six due to overhead equipment problems, four due to animals, and five were due to unknown causes. Tree trimming for this circuit was last completed in November of 1999, and is not scheduled again until spring of 2004. Staff's inspection revealed that tree conditions are very bad throughout the circuit (Photos 6-11). In fact, vegetation issues were the only items noted by Staff. It is likely that weather-related interruptions and those interruptions classified as unknown could significantly be reduced if trees adjacent to this circuit were adequately trimmed. Staff is pleased with AmerenCIPS plans to install 35 tap line fuses, which will cause interruptions to affect fewer customers, but feels the priority for this circuit should be tree trimming.

**Photo 6: Tree Growth around Primary and Transformer (S86-582)**

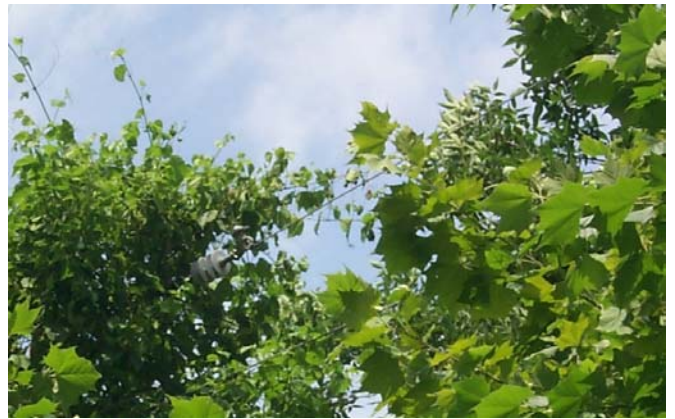
**Photo 9: Pole Covered by Shrubs and Vines with only Dead-end Insulator in View (S86-582)**

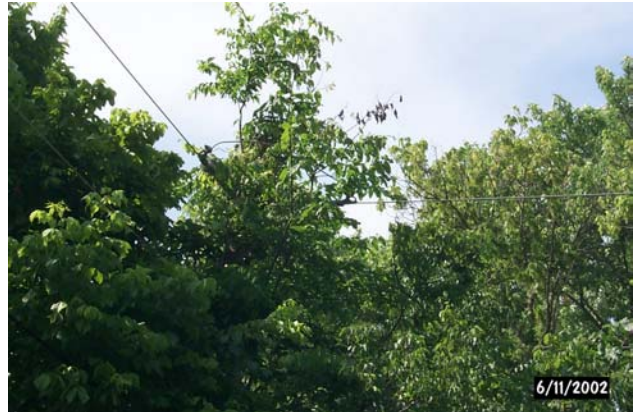
**Photo 10: Young Tree Surrounding Corner Pole (S86-582)**

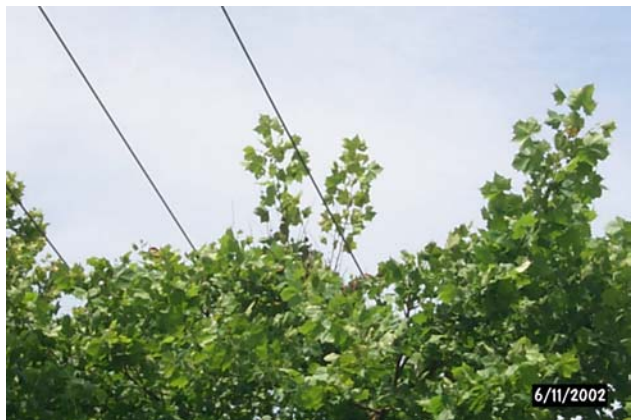
**Photo 8: Tree Branches Growing between Phase Wires (S86-582)**

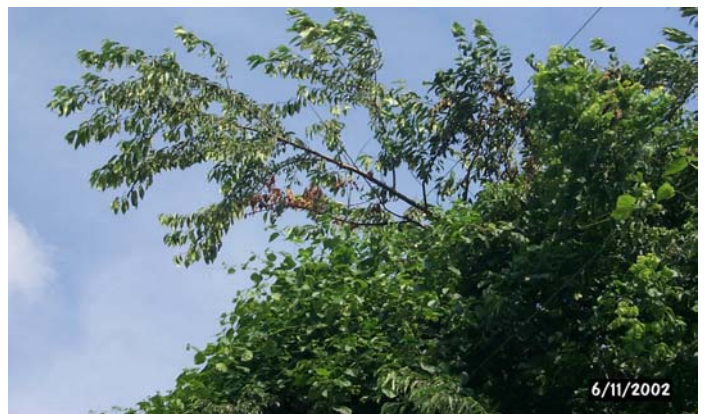
**Photo 11: Limb Burning on Primary (S86-582)**

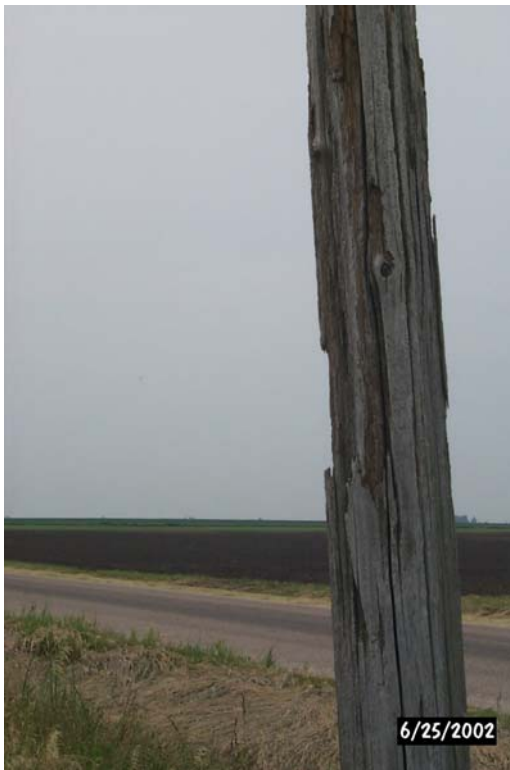
- **Circuit V58-507 (Four Rivers Region):** SAIFI=CAIFI=4.0; CAIDI=116  
This 12kV circuit supplies residential and agricultural customers in and around the communities of Roseville and Swan Creek. V58-507 was not listed by AmerenCIPS as a worst performing circuit in 2001 only because two other circuits in Four Rivers Region had a SAIFI that was even worse. Of the twenty-eight outages on this circuit in 2001, nine were intentional, six were weather-related, five were due to animals, four due to overhead equipment problems, and only one was due to unknown causes. Tree trimming for this circuit was last completed in December of 2001, and not scheduled again until fourth quarter of 2005. Staff noted that AmerenCIPS reported no tree-related interruptions on this circuit during 2001. Staff did not observe any tree contacts on this circuit, and noted adequate clearance between the trees and wires throughout. Nearly all the reliability concerns noted during Staff's inspection related to aging facilities, such as shell-rot poles, split pole tops, or broken cross arms (Photos 12-14). Staff also noted there were no lightning arresters seen on this circuit.

**Photo 12: Shell-rotted Pole (V58-507)**

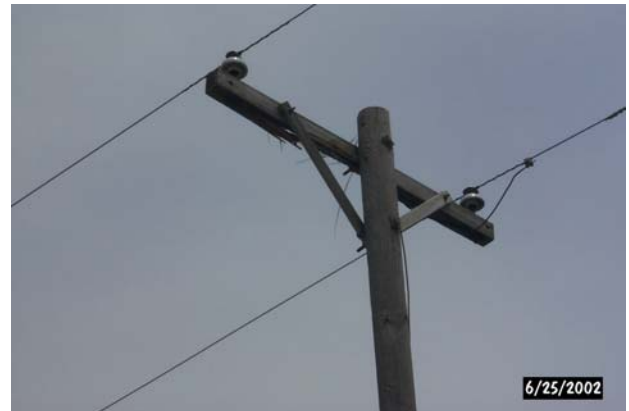
**Photo 13: Example of Failing Cross Arm (V58-507)**

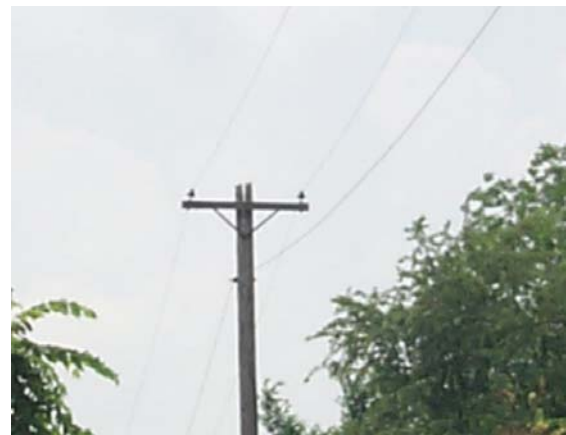
**Photo 14: Example of Pole with Split Top (V58-507)**

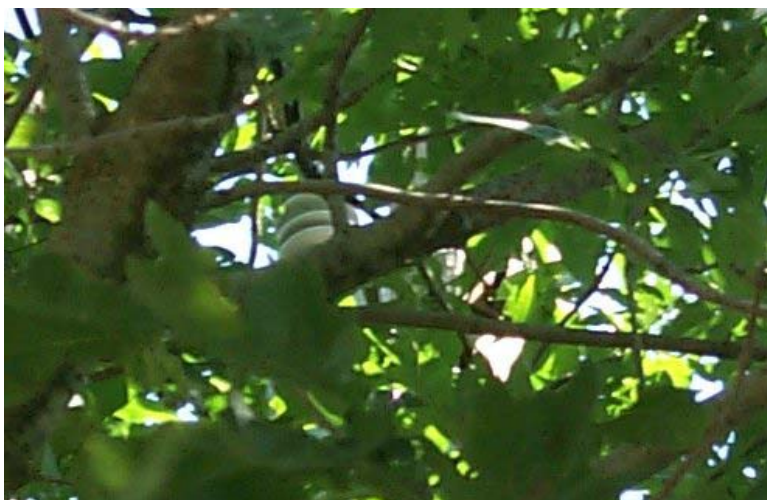
- **Circuit V22-555 (Eagle View Region):** SAIFI=3.9; CAIFI=4.1; CAIDI=139  
This 12kV circuit, a 2001 worst performing circuit due to SAIFI, supplies mostly agricultural and residential customers in and around the communities of Shipman and Piasa. V22-555 had a relatively high SAIFI last year (2000 SAIFI=2.9). Of the fifty-nine outages on this circuit in 2001, twenty-six were weather related, ten due to overhead equipment problems, eight due to animals, and ten were due to unknown causes. AmerenCIPS reported none of the outages as tree-related. Tree trimming for this circuit was last completed in 2000, and next scheduled for the fourth quarter of 2003. AmerenCIPS states that no additional reliability improvements are scheduled for this circuit at this time. Staff found several locations where trees were contacting the primary (Photos 15-16). In addition, AmerenCIPS facilities showed varying signs of deterioration, specifically shell-rot poles and split pole tops (Photos 17-18). This circuit would likely benefit from well-placed lightning arresters, given the high number of interruptions categorized as weather-related, and signs of lightning damage on some poles. Staff observed no lightning arresters on the circuit.

**Photo 15: Transformer and Primary Completely Covered by Mature Tree (V22-555)**

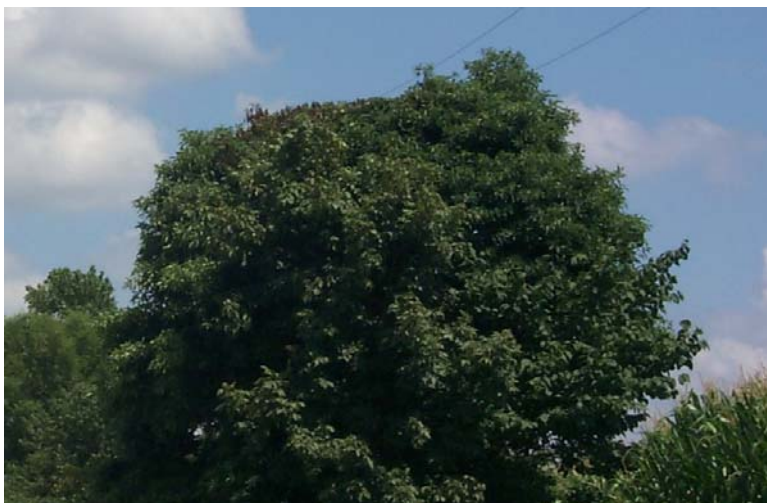
**Photo 16: Tree Growing into Primary and Burning (V22-555)**

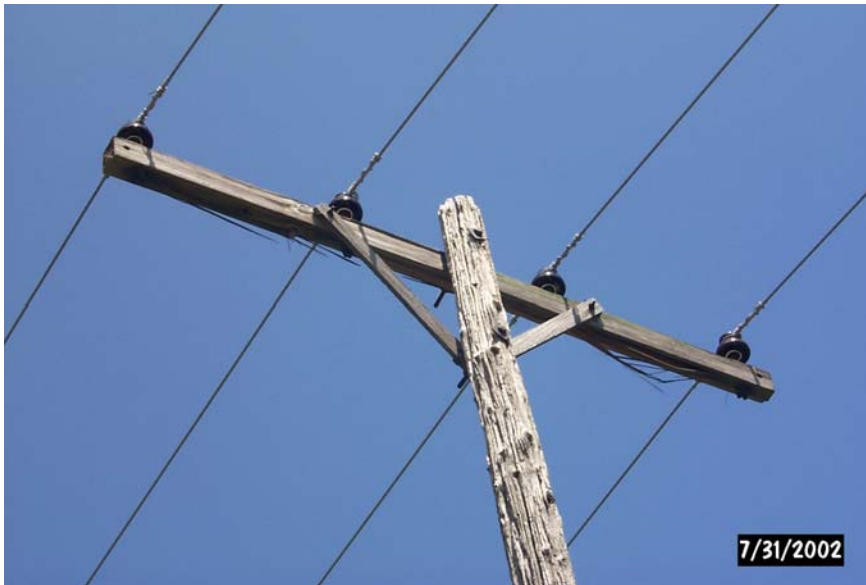
**Photo 17: Splintered Cross Arm on Shell-rot Pole (V22-555)**

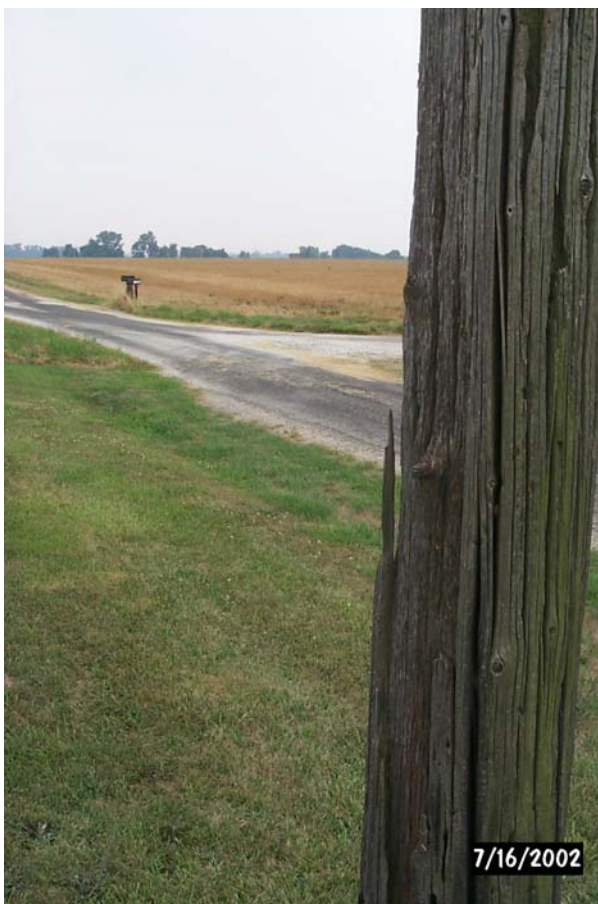
**Photo 18: Example of Shell-Rot Pole (V22-555)**
